INDOOR AIR QUALITY ASSESSMENT

**Buckland Town Offices
17 State Street
Buckland, Massachusetts**

Prepared by:
Massachusetts Department of Public Health
Center for Environmental Health
Emergency Response/Indoor Air Quality Program
August 2005

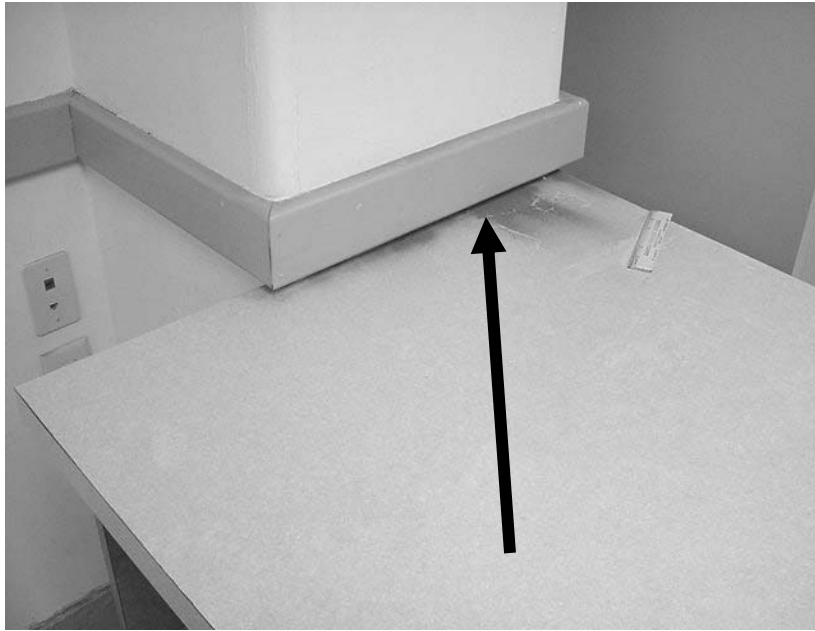
Picture 1

Buckland town officials discovered that the chimney venting the new furnace was leaking into the Assessor's office (Picture 1). Air sampling by MDPH confirmed that the newly installed furnace was venting products of combustion into the building. A March 1, 2005 letter documented conditions found at the time of the January 6, 2005 visit and listed a number of recommendations to improve air quality (MDPH, 2005). As a result, repairs were made to the chimney to ensure proper venting of furnace exhaust. Mr. Feeney revisited the BTO on June 1, 2005 to determine whether mitigation efforts were successful.

Area of Chimney Leak in Assessor's Office

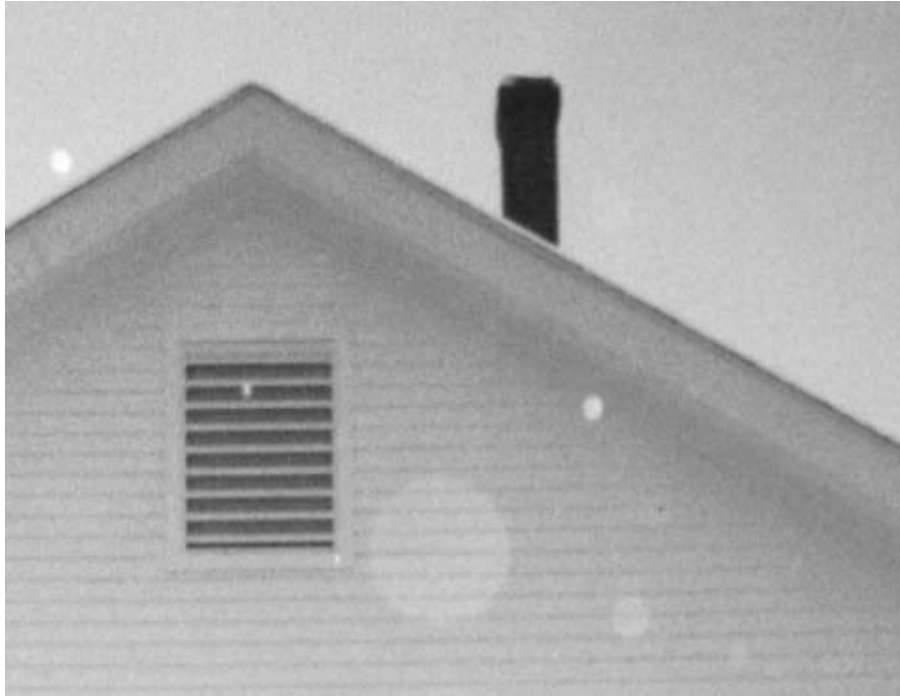
Picture 2

The purpose of the June 1, 2005 visit was to conduct air sampling to ascertain whether repairs to the furnace and chimney were effective to vent combustion products from the building. The casing of the furnace had been repaired and a metal sheath with cap (Pictures 2 and 3) was installed inside the chimney to repair any gaps that may have existed in the chimney. The furnace was induced to fire during this evaluation in order to sample around the furnace in a similar manner to the January 6, 2005 assessment. Although, a slight rise in carbon dioxide was detected above the furnace while the furnace

Chimney of BTH before Repair

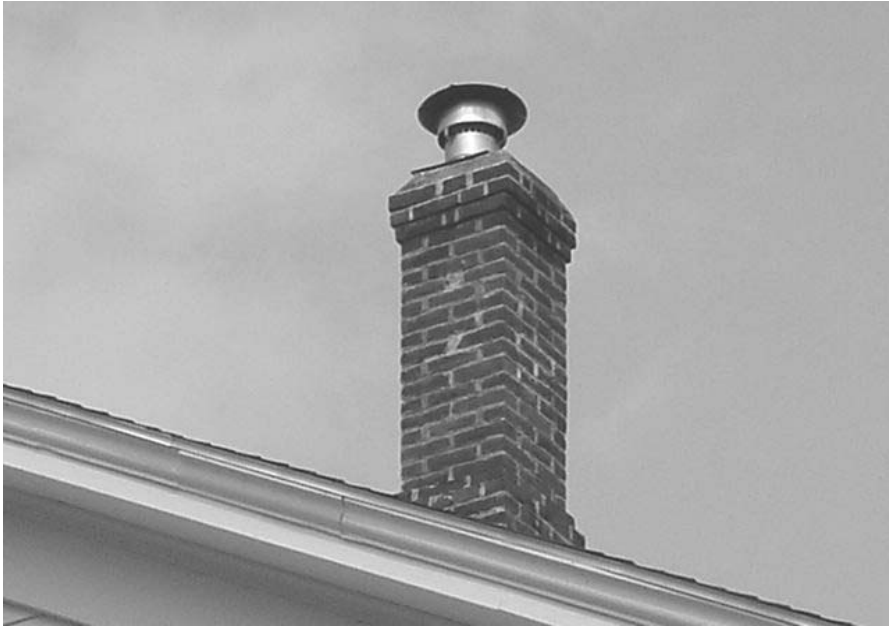
Picture 3

Chimney of BTH after Repair, Note Cap
